Reference: NHTSA Identification Number 07V-473

## **Safety Recall G39**

### **Radiator Fan Motor Connector**

2007 - 2008 (JS) Chrysler Sebring and Dodge Avenger

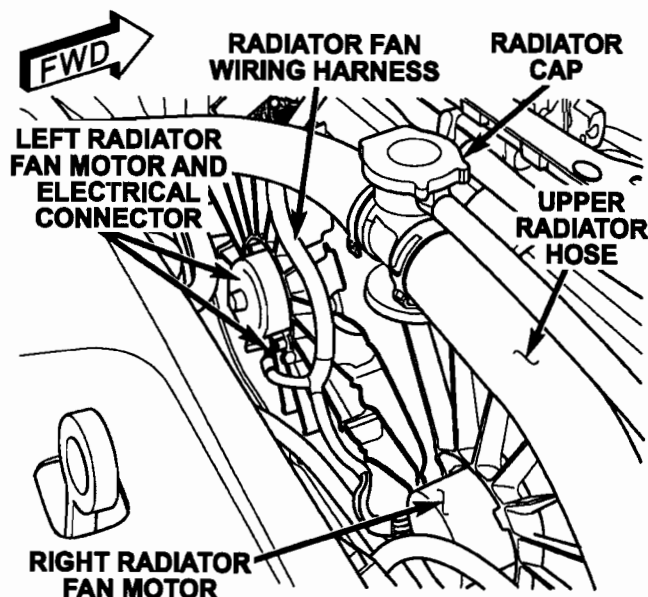
**Figure 1**

3. Disconnect the left (driver's side) radiator fan motor electrical connector at the fan motor (Figure 1).

4. Inspect the radiator cooling fan motor connector:

- If the radiator cooling fan motor connector **is melted or the motor terminal is discolored from overheating**, replace the left radiator fan motor. Continue with Step 5 of this procedure.
- If the radiator cooling fan motor connector **is NOT melted and the motor terminal is NOT discolored from overheating, but engine coolant is found** in the motor side of the connector, clean out the coolant using Mopar Electrical Contact Cleaner (P/N 05018045AA) or equivalent. Continue with Step 6 of this procedure.
- If the radiator cooling fan connector **is NOT melted, the motor terminal is NOT discolored from overheating** and there is **no engine coolant found** in the motor side of the connector, continue with Step 6 of this procedure.
